ST. ELIZABETHS WEST CAMPUS CEMETERY: PRESERVATION PLANNING UPDATE

Prepared By:
Michael Trinkley, Ph.D.
and
Debi Hacker

November 2016

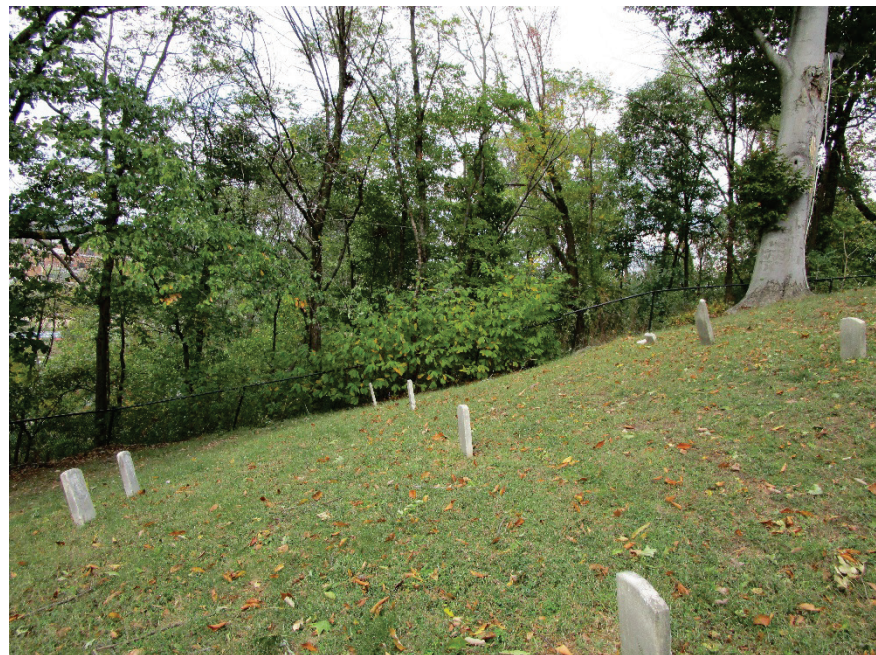
Figure 5. Thick vegetation along the west side of the cemetery.

Some aspects of this have been accomplished, but only in the direction of the Coast Guard facilities (see Figure 4). Elsewhere, no effort has been made to clean up downed trees or thin vegetation (Figure 5).

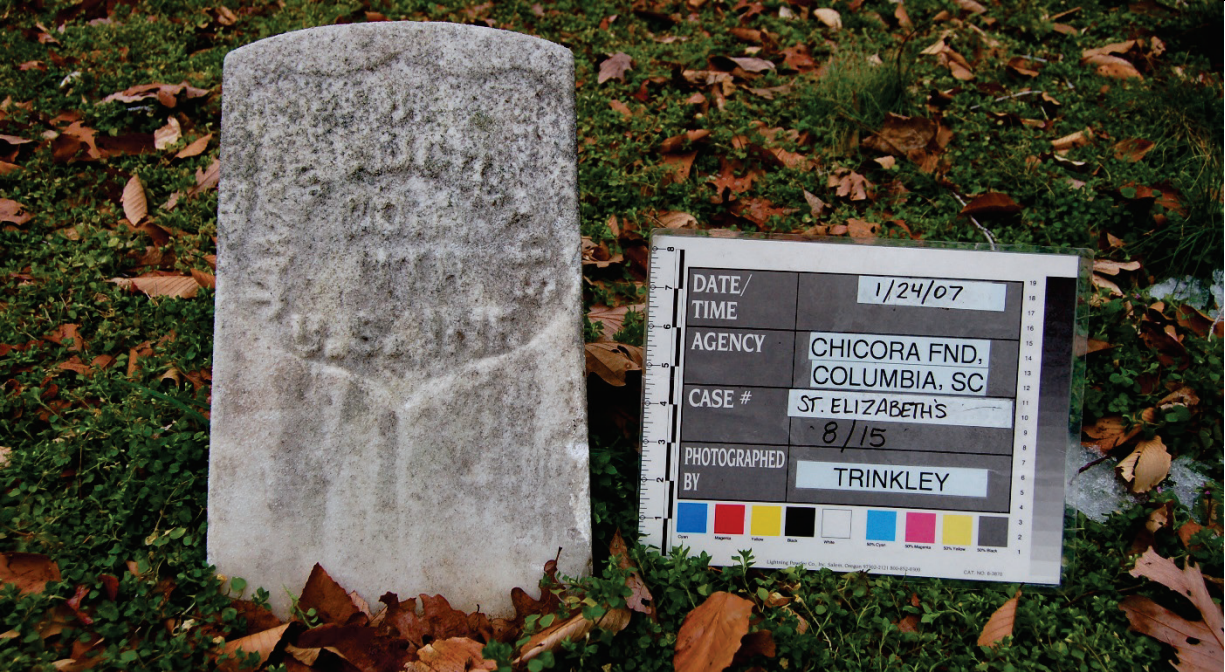
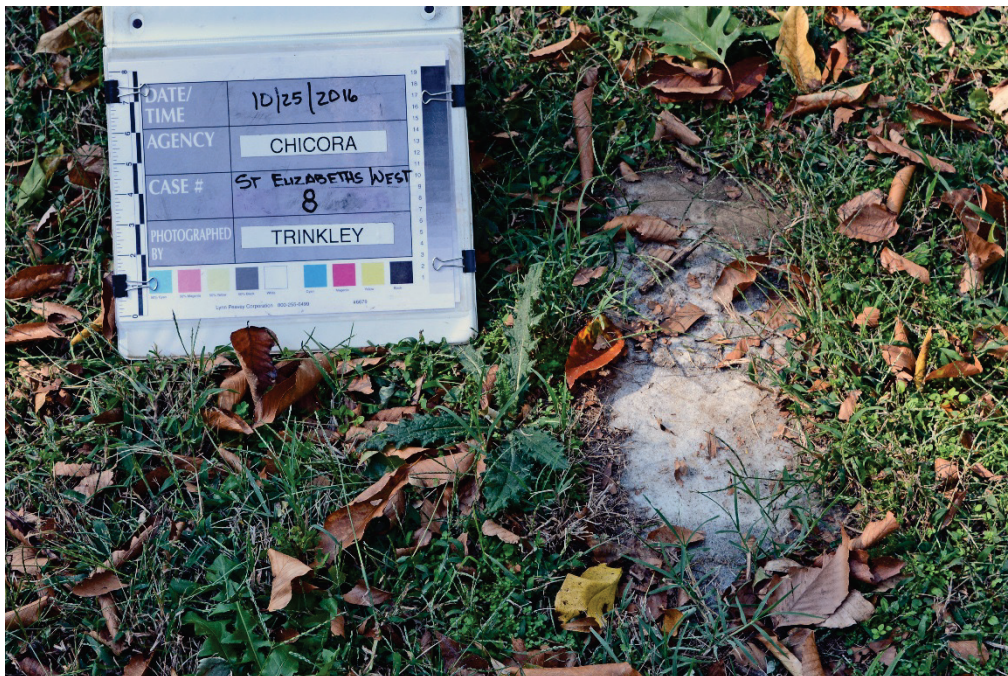
Grave #: 8

Condition of Marker: ☒ weathered ☐ cracked ☐ broken ☐ vandalized
☐ unattached ☐ loose ☒ biologicals ☐ stained
☐ repaired ☒ portions missing: chips mid left side – mower damage
☒ tilted: degrees: 45 E-W 5 N-S Other:

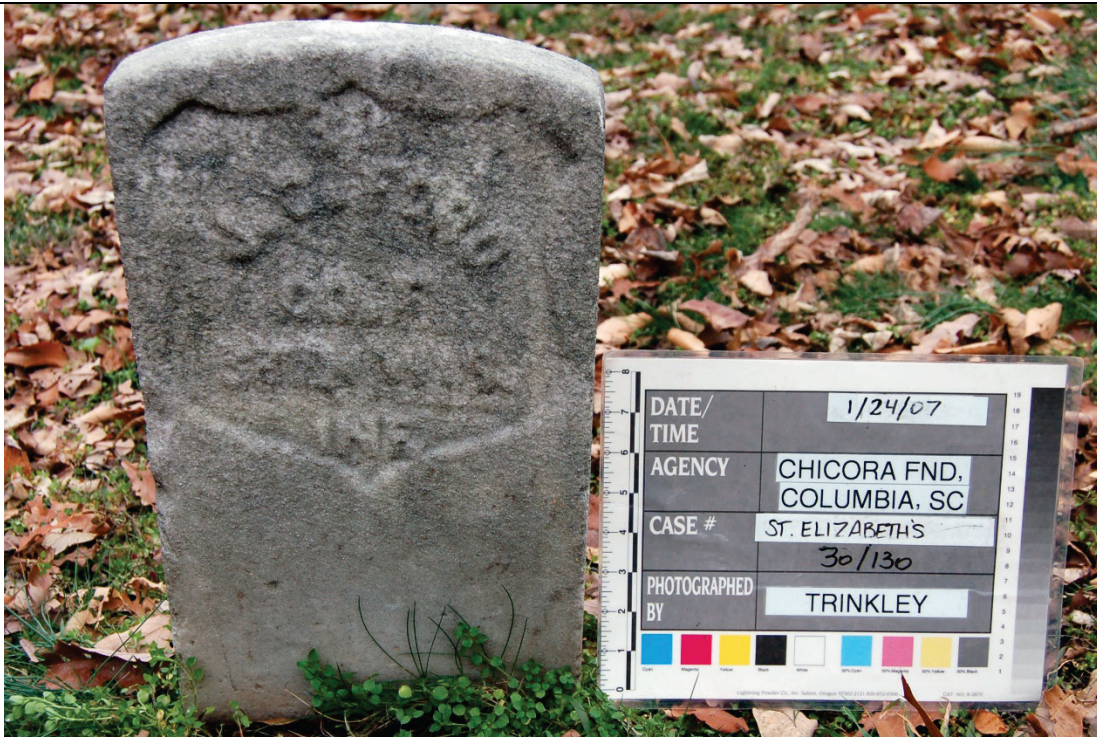
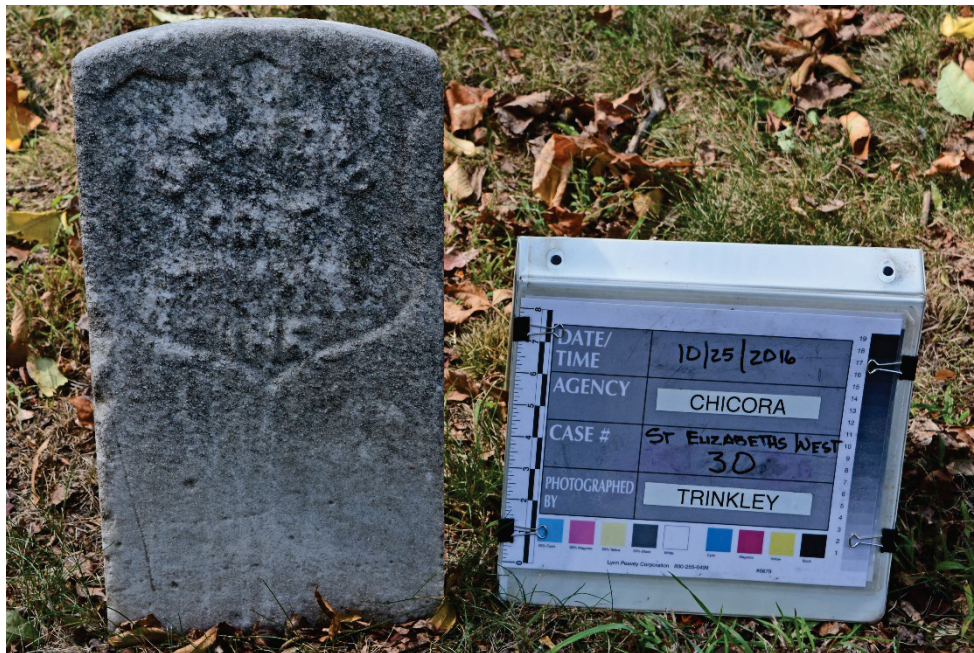
Grave #: 30

Condition of Marker: ☒ weathered ☐ cracked ☒ broken ☐ vandalized
☐ unattached ☒ loose ☒ biologicals ☐ stained
☐ repaired ☒ portions missing: chunk right side – mower damage
☐ tilted: degrees: E-W N- Other: fallen since 2007
 S

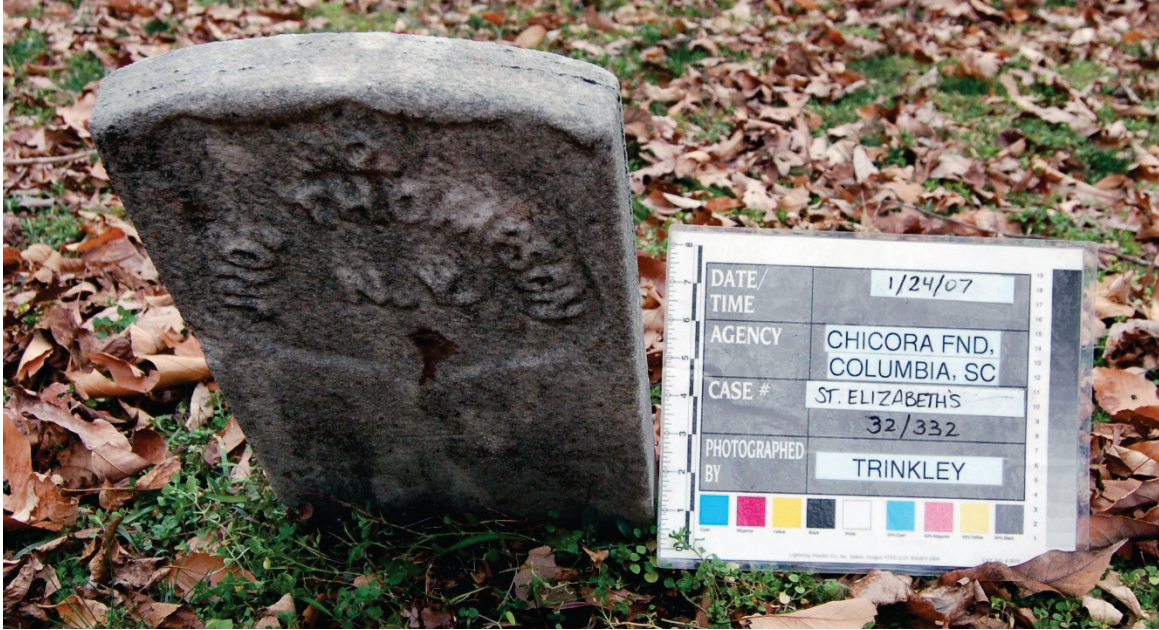
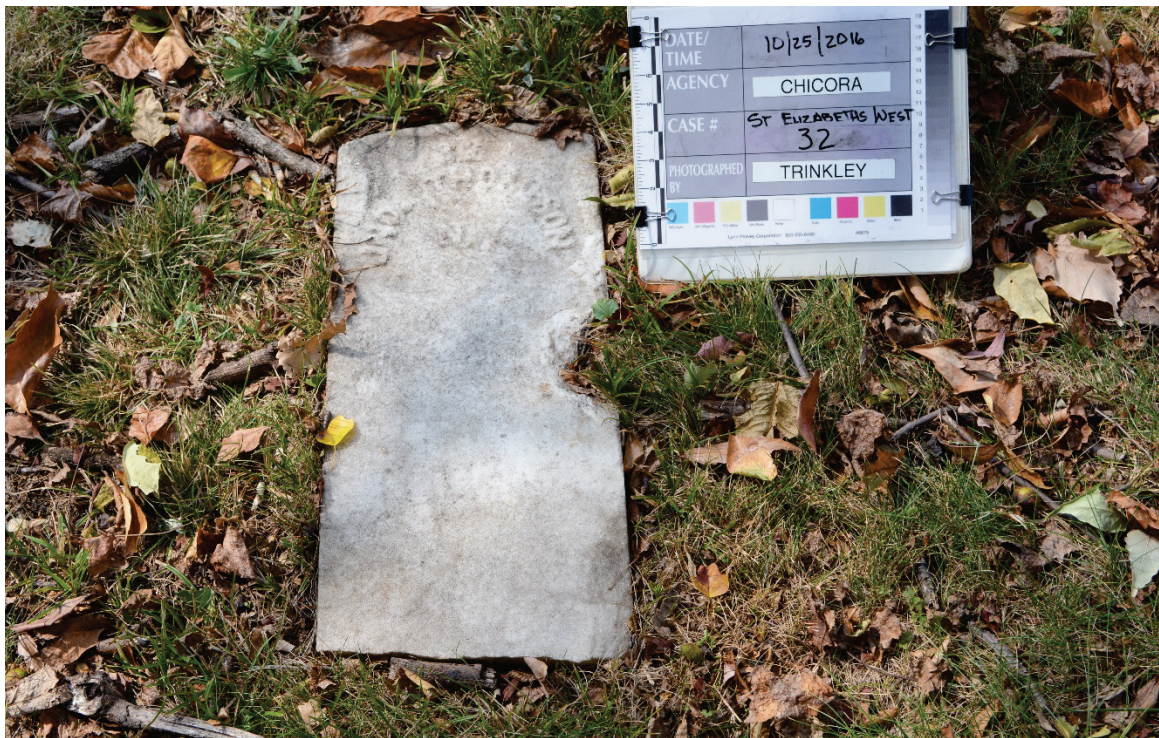
Grave #: 32

Condition of Marker: ☒ weathered ☐ cracked ☐ broken ☐ vandalized
☐ unattached ☒ loose ☒ biologicals ☐ stained
☐ repaired ☒ portions missing: chips right and left sides
☐ tilted: degrees: E-W N- Other: fallen since 2007
 S

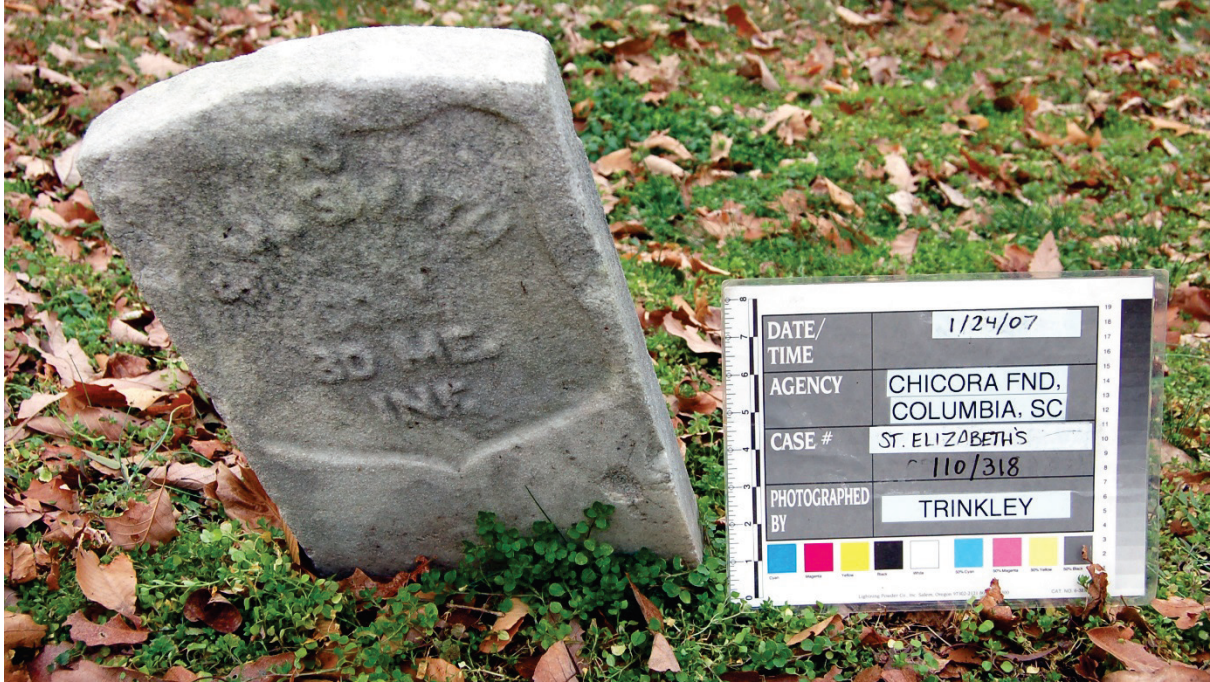
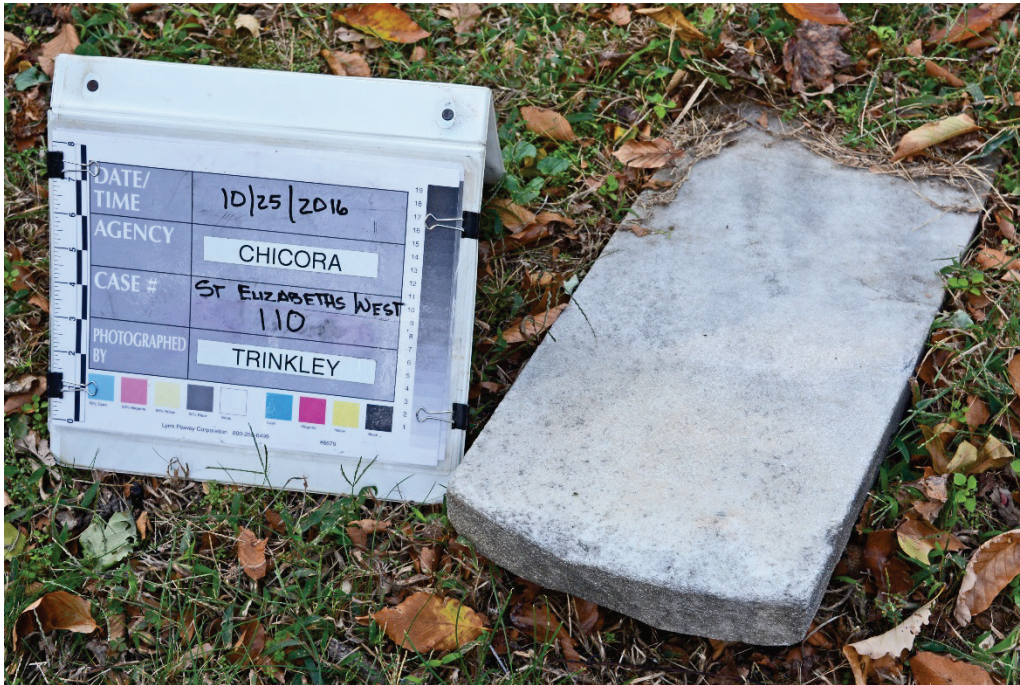
Grave #: 110

Condition of Marker: ☒ weathered ☐ cracked ☐ broken ☐ vandalized
☐ unattached ☒ loose ☒ biologicals ☐ stained
☐ repaired ☒ portions missing: chipped right and left sides
☐ tilted: degrees: E-W N- Other: fallen since 2007
 S
